## **Report on Preliminary Site Investigation for Contamination**

**Bromelton Energy and Resource Centre,  
Lot 1 Beaudesert Boonah Rd**

**Prepared for Cleanaway Operations Pty  
Ltd**

**Project 219361.01**

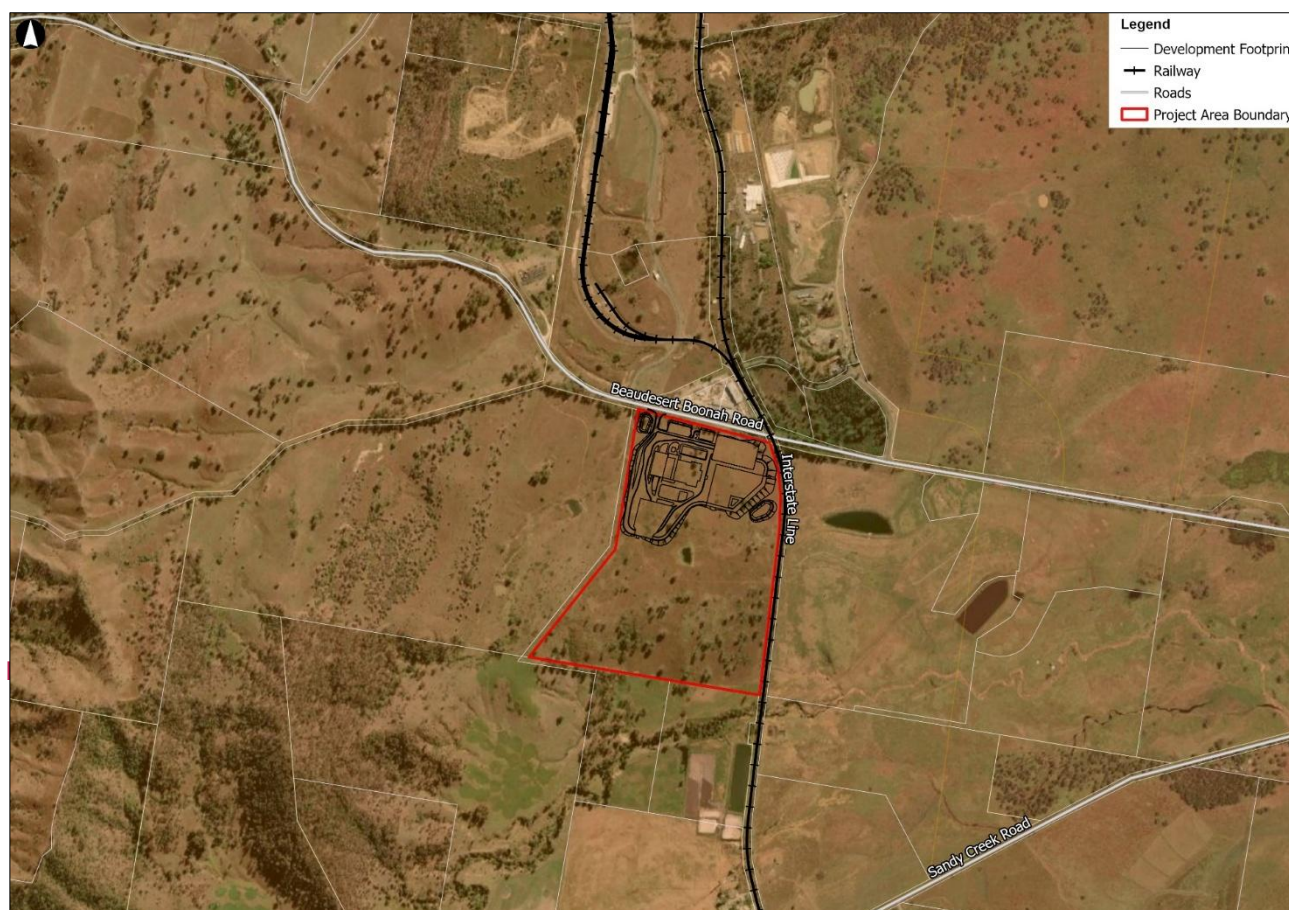
**Figure 2: Site location and lot boundaries (red)**

The site identification details are presented in Table 2 below and the project area boundaries are outlined in Figure 2 below. The site boundaries (i.e. the investigation area for this report) are shown on Drawing 1 provided in Appendix B.

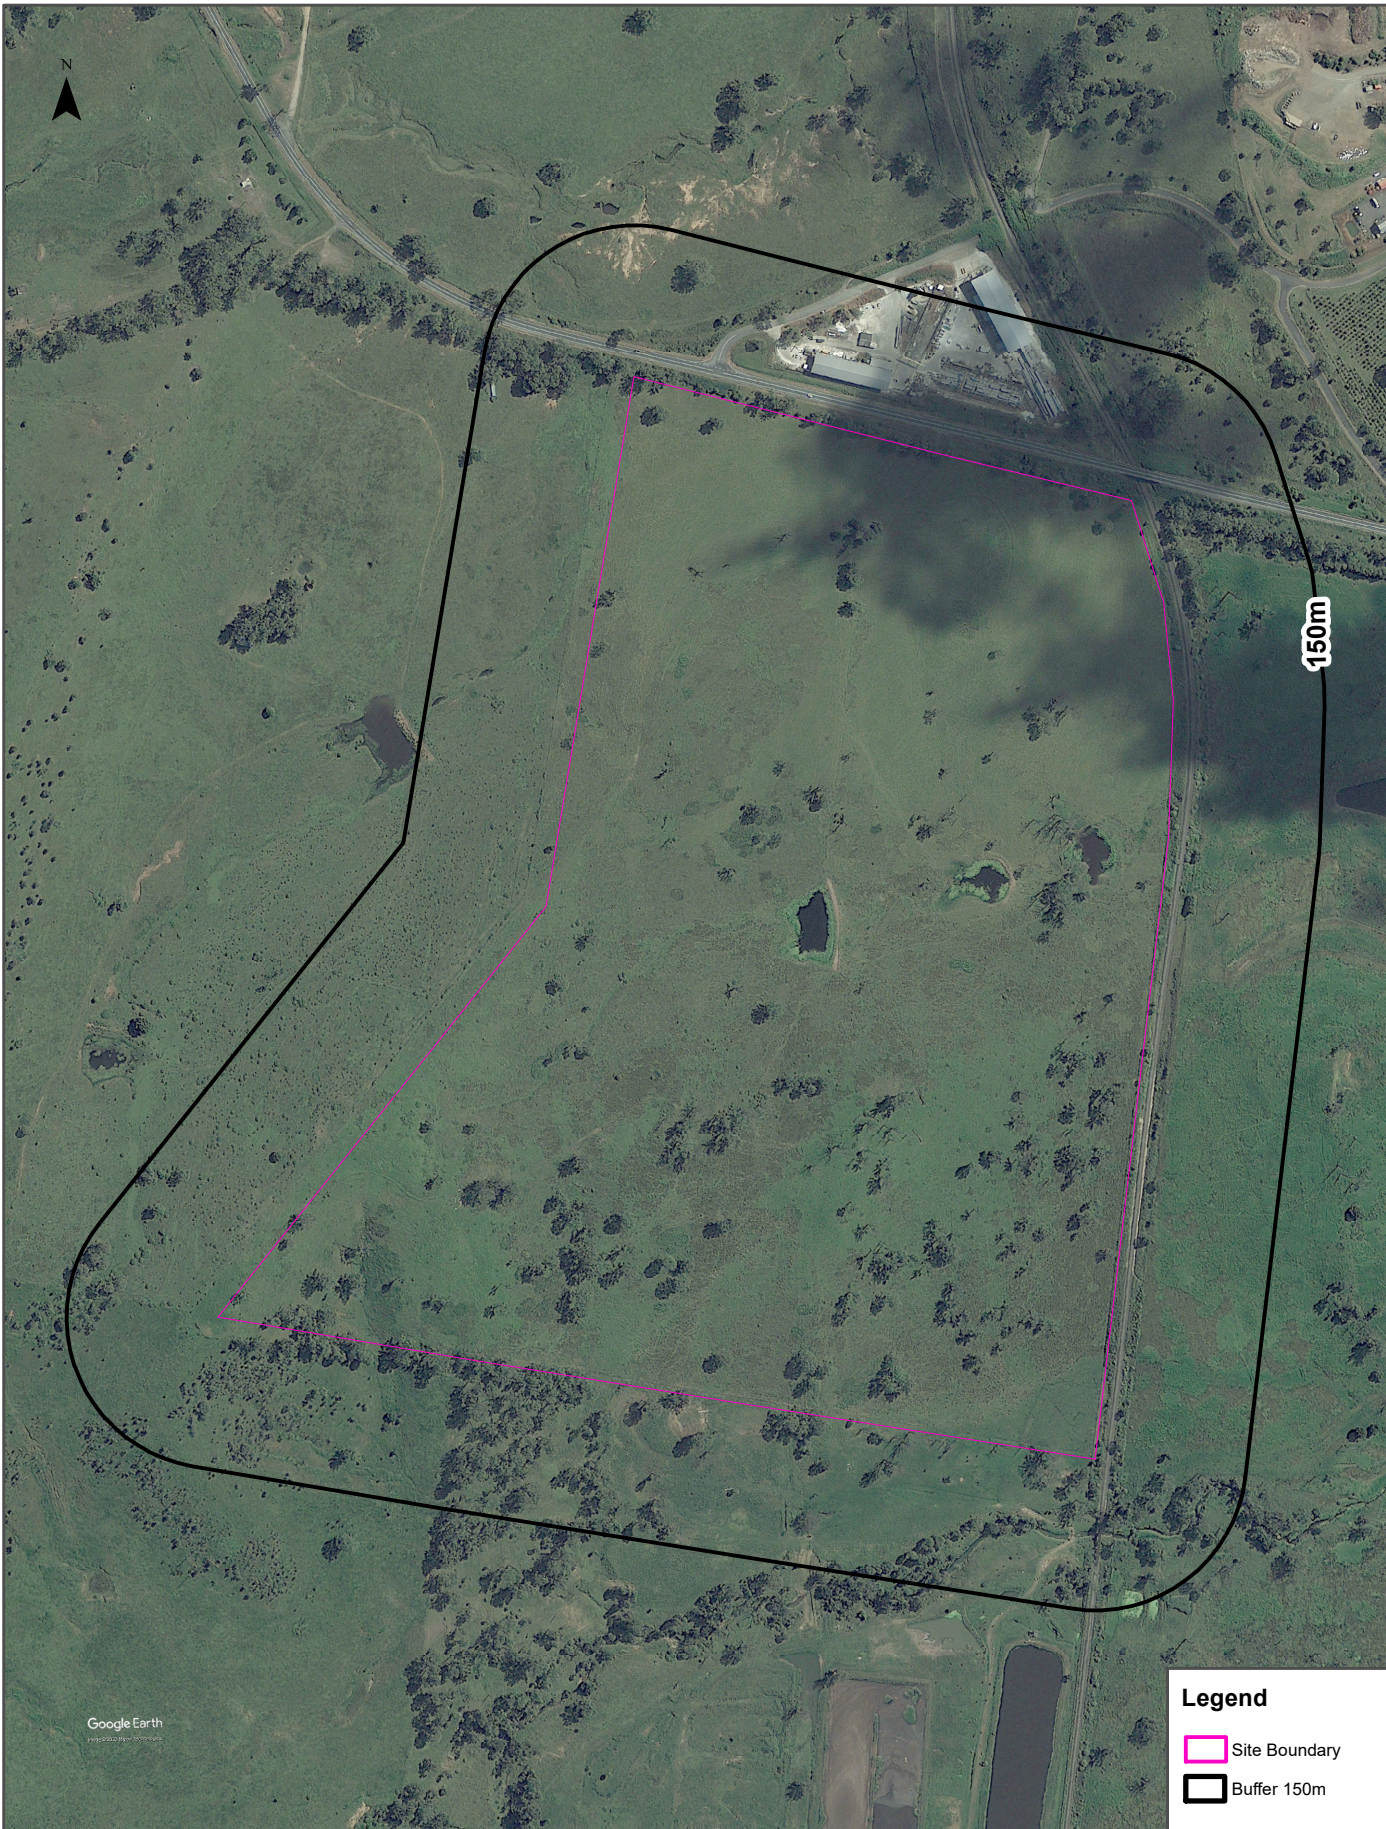
# Aerial Imagery 2012

| Year | Lot 1 on RP45234 | Surrounding land use |
|---|---|---|
| 2012 | The lot appeared similar to the 2004 image. | Industrial structures appeared to have been constructed north of the site, within the triangular-shaped block across Beaudesert Boonah Road. Earthworks were observed approximately 400 m north-east of the site. |

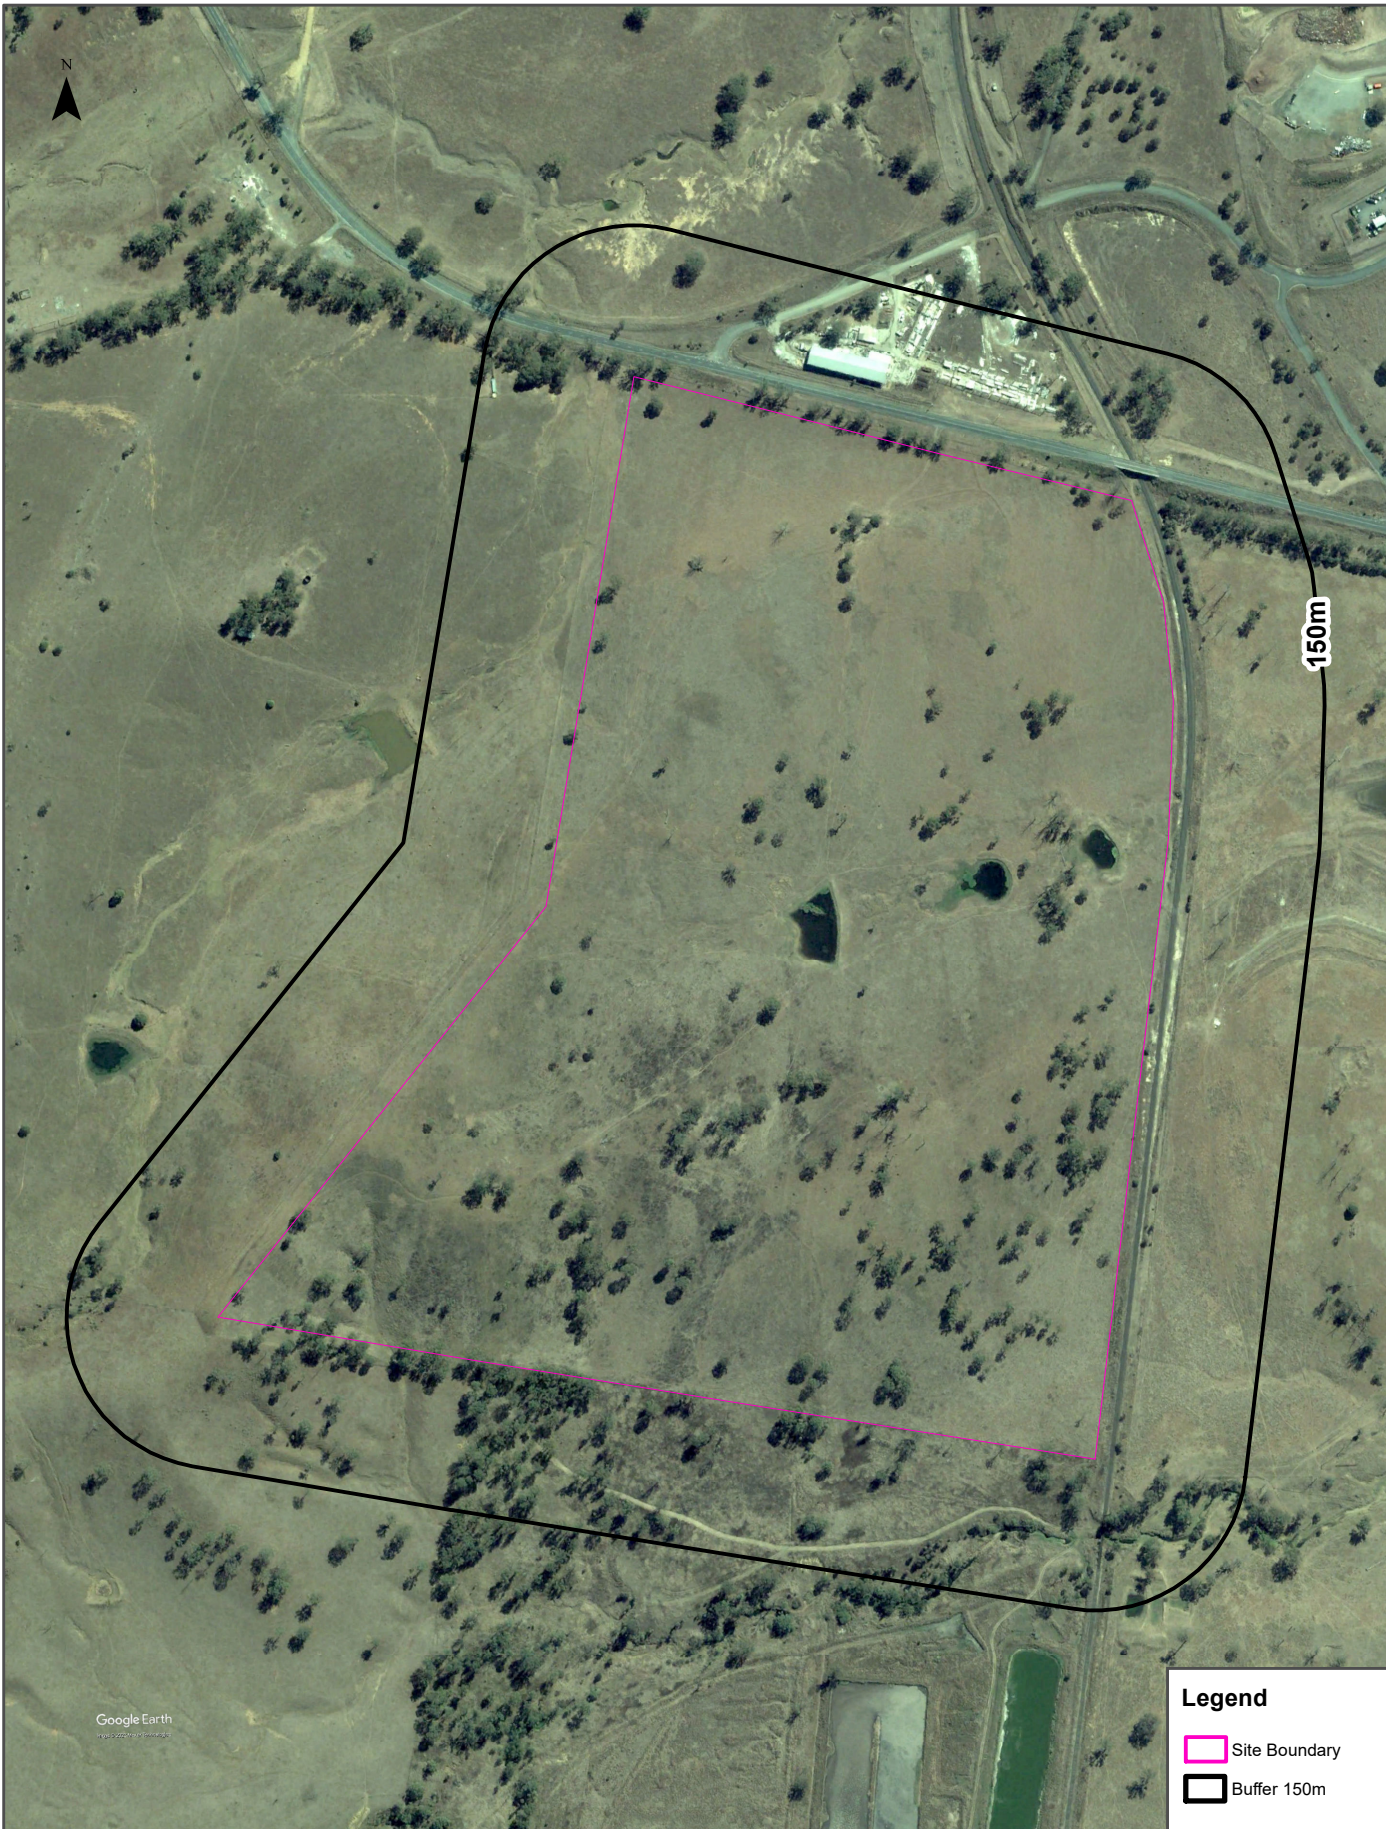
# Aerial Imagery 2004

| Year | Lot 1 on RP45234 | Surrounding land use |
|---|---|---|
| 2004 | The lot appeared similar to the 1993 image. | A road had been constructed north of the northern boundary of the site, connecting previous roads. A triangular-shaped block of land directly north of the site appeared to have been developed for industrial purposes. Additional structures were also observed approximately 300 m north-west of the site. The possible cattle yards located directly east of the site appeared to have ceased activities and a small structure was located south of it. A large dam was observed approximately 150 m west of the site. |

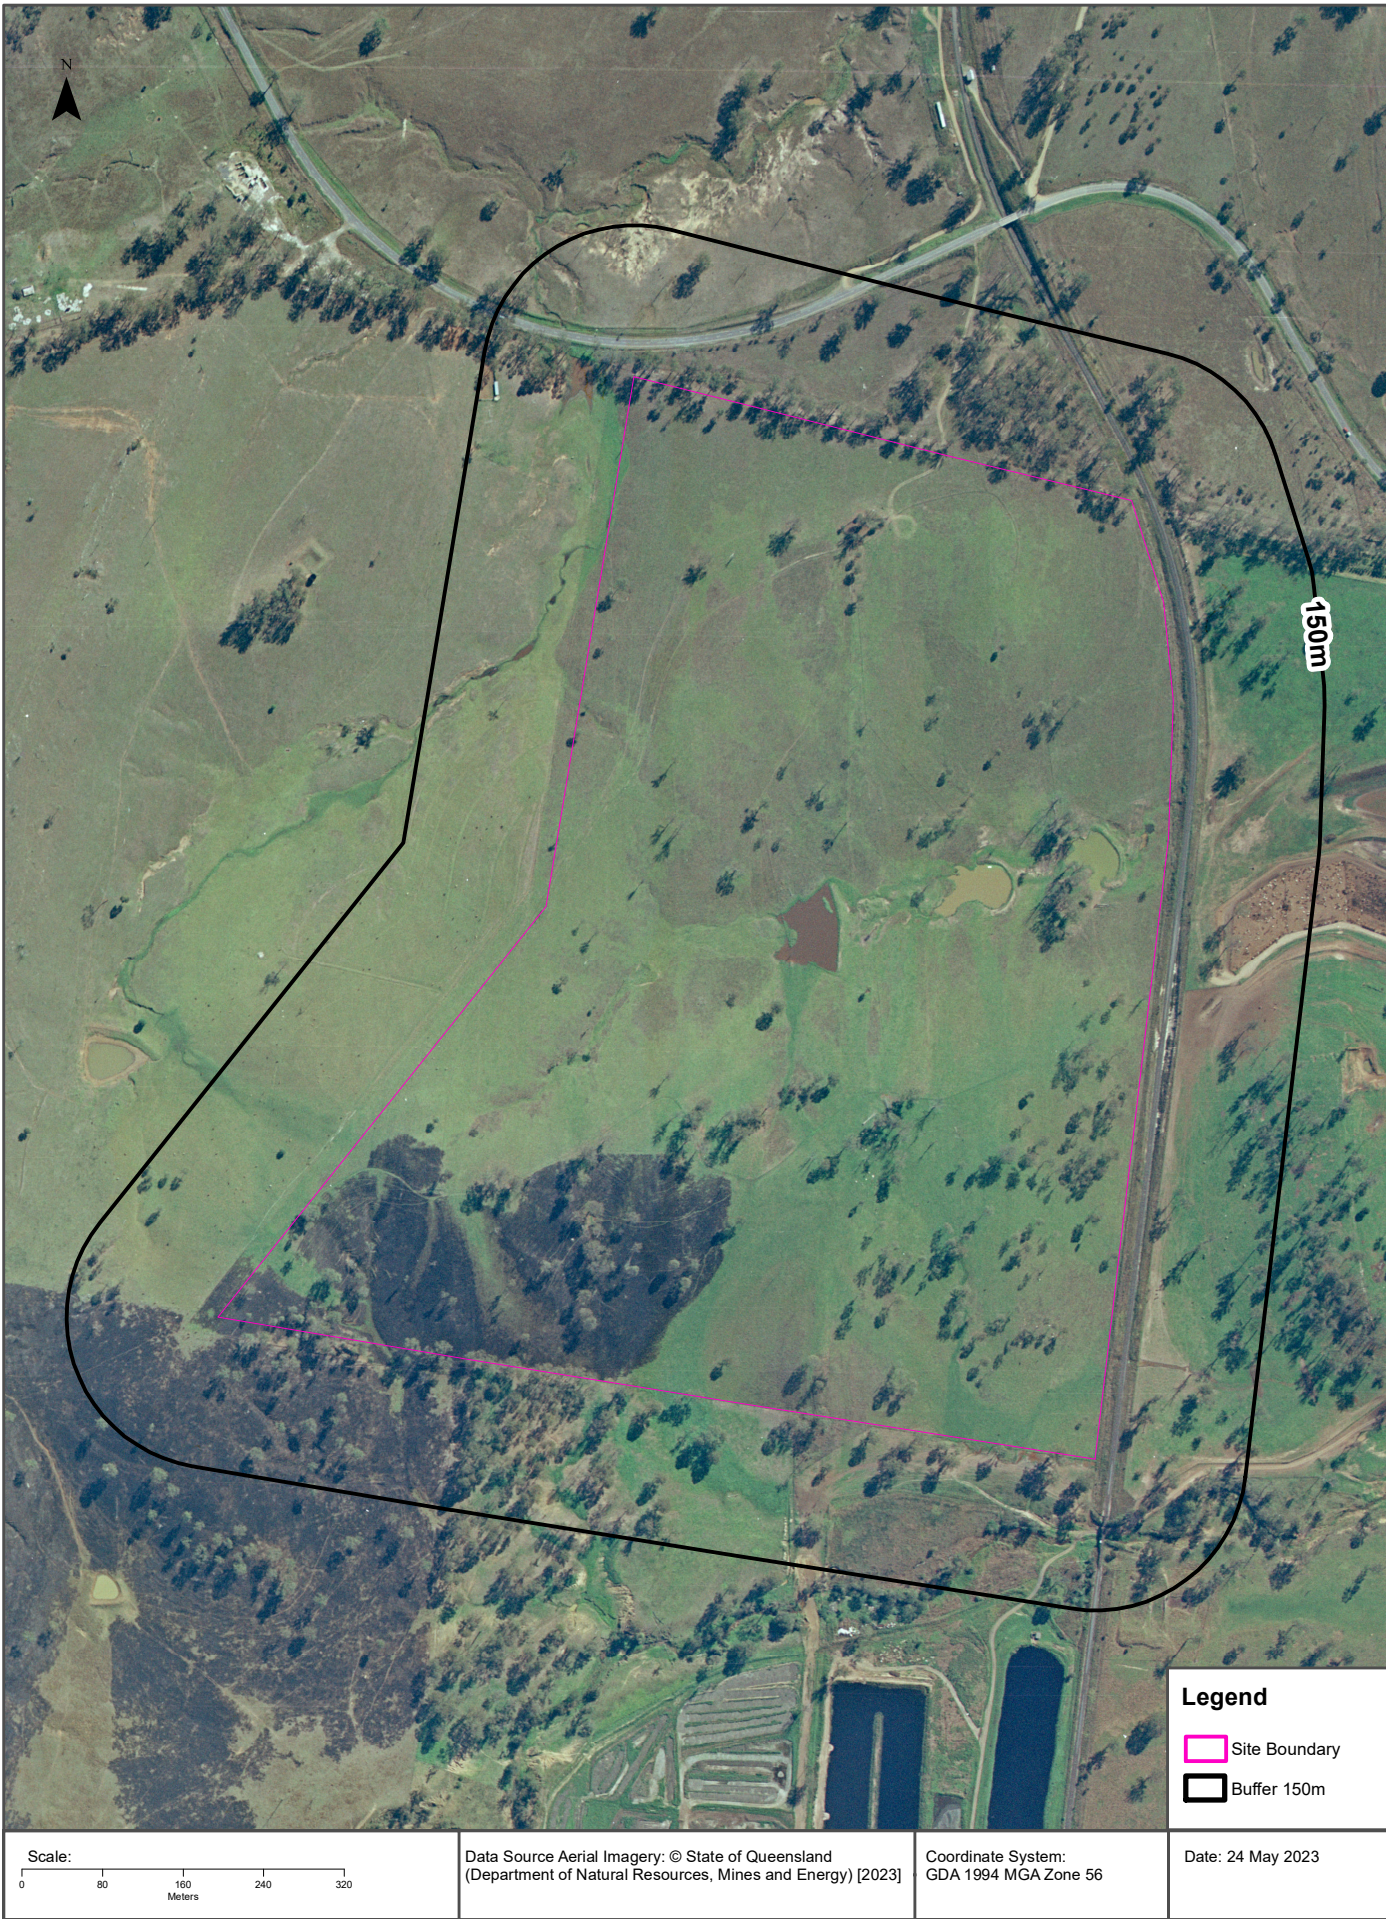
# Aerial Imagery 1993

| Year | Lot 1 on RP45234 | Surrounding land use |
|---|---|---|
| 1993 | A dam near the centre of the lot had increased in size. A track was observed leading from the northern boundary to the north-western structures. Increased vegetation was observed in the south-western corner of the lot. | Possible stockpiles and soil disturbance were observed to the west and north-west of the site. A possible cattle yard was observed directly east of the site. Earthworks were observed west of the retention pond/dams located south of the lot. |

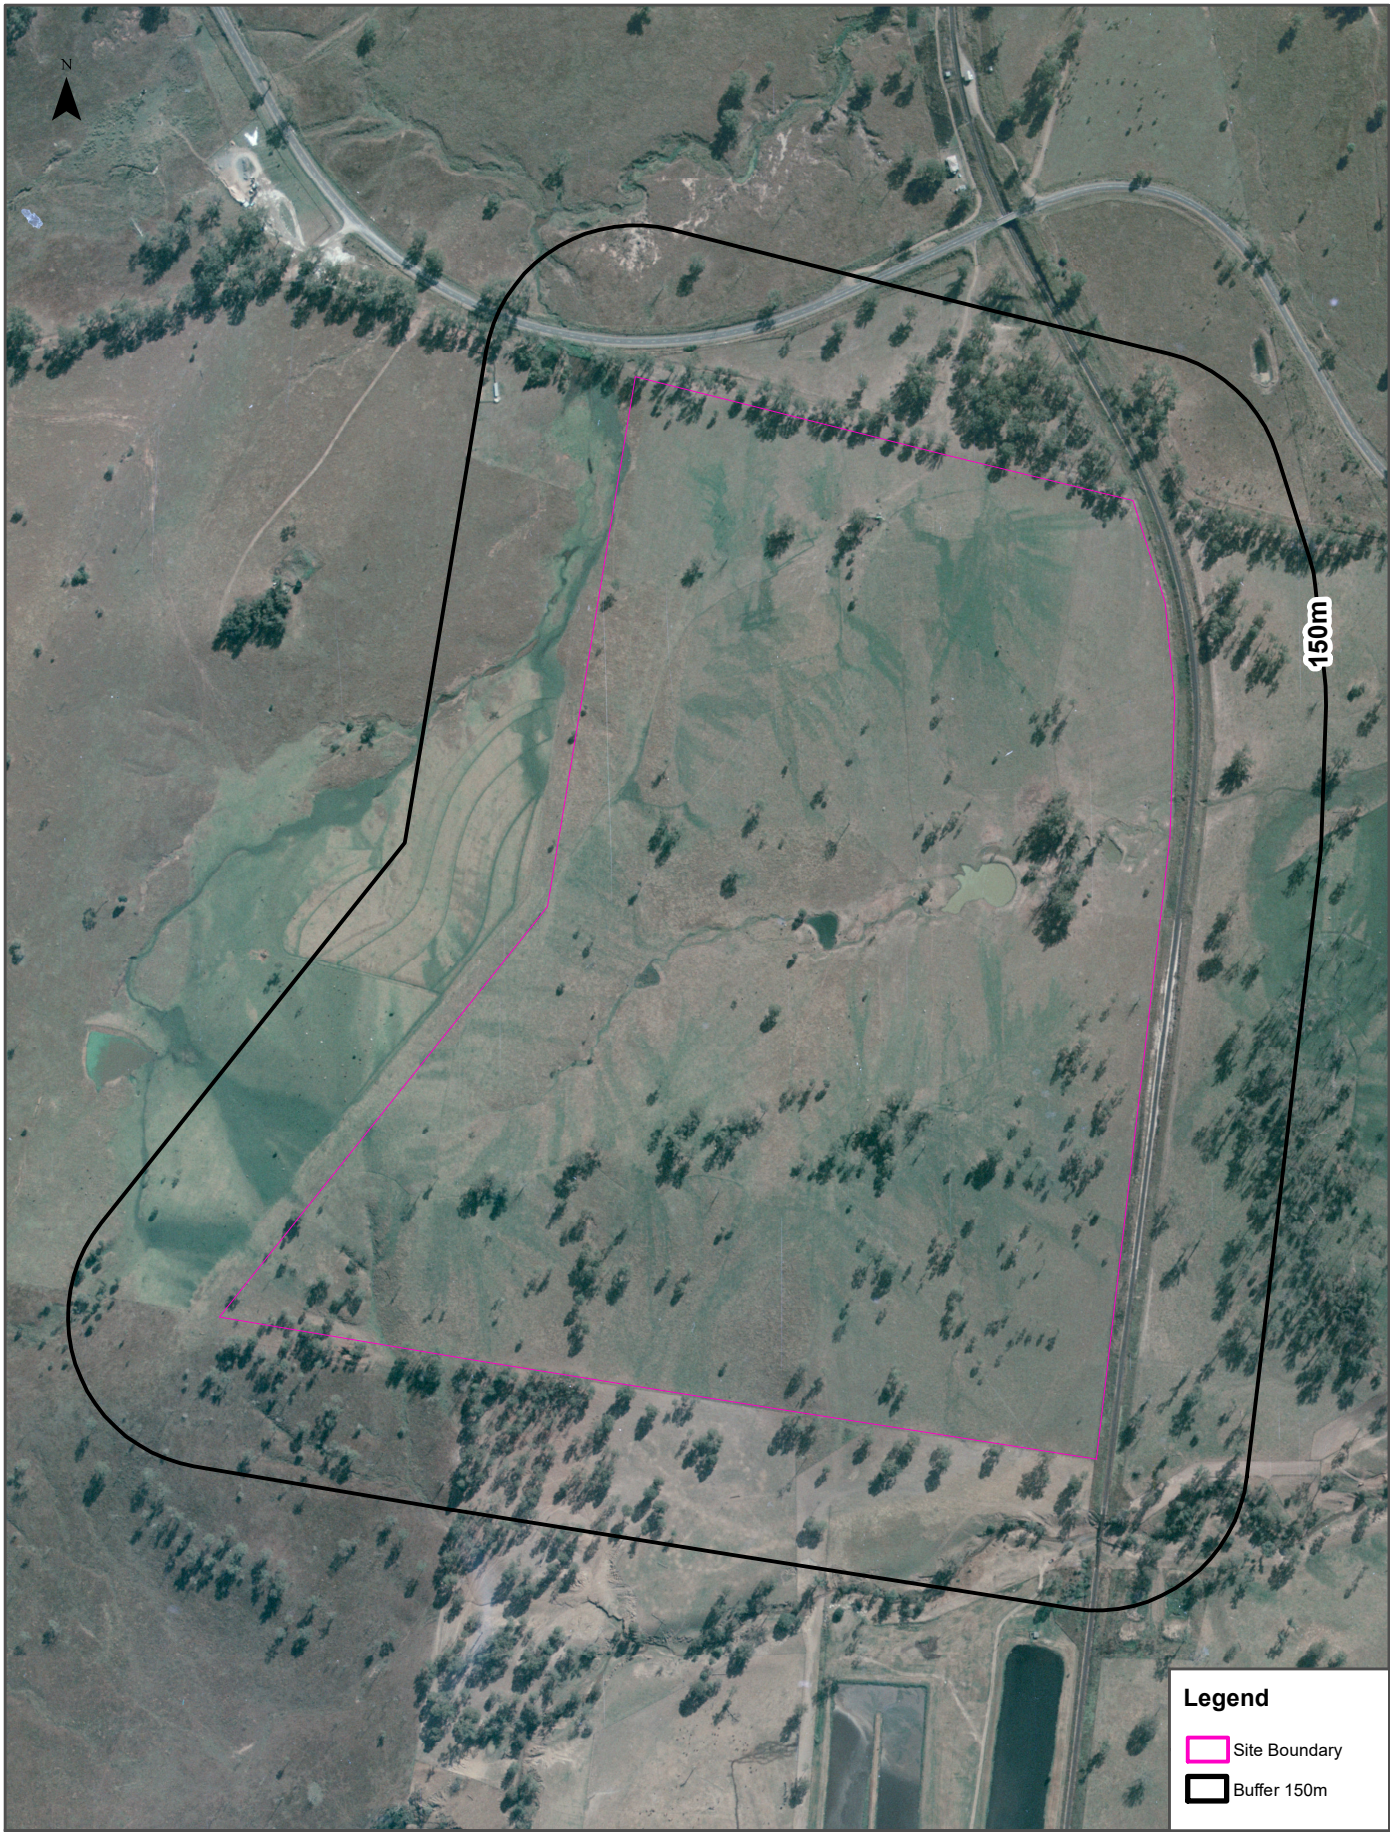
# Aerial Imagery 1982

| Year | Lot 1 on RP45234 | Surrounding land use |
|---|---|---|
| 1982 | The lot appeared similar to the 1974 image. | Extensive earthworks were observed approximately 450 m north-west of the site. A fenced area was observed near the structures located 320 m west of the site. An additional retention basin appeared to have been constructed south-east of the lot. Several smaller structures to the north of the site appeared to have been removed. |

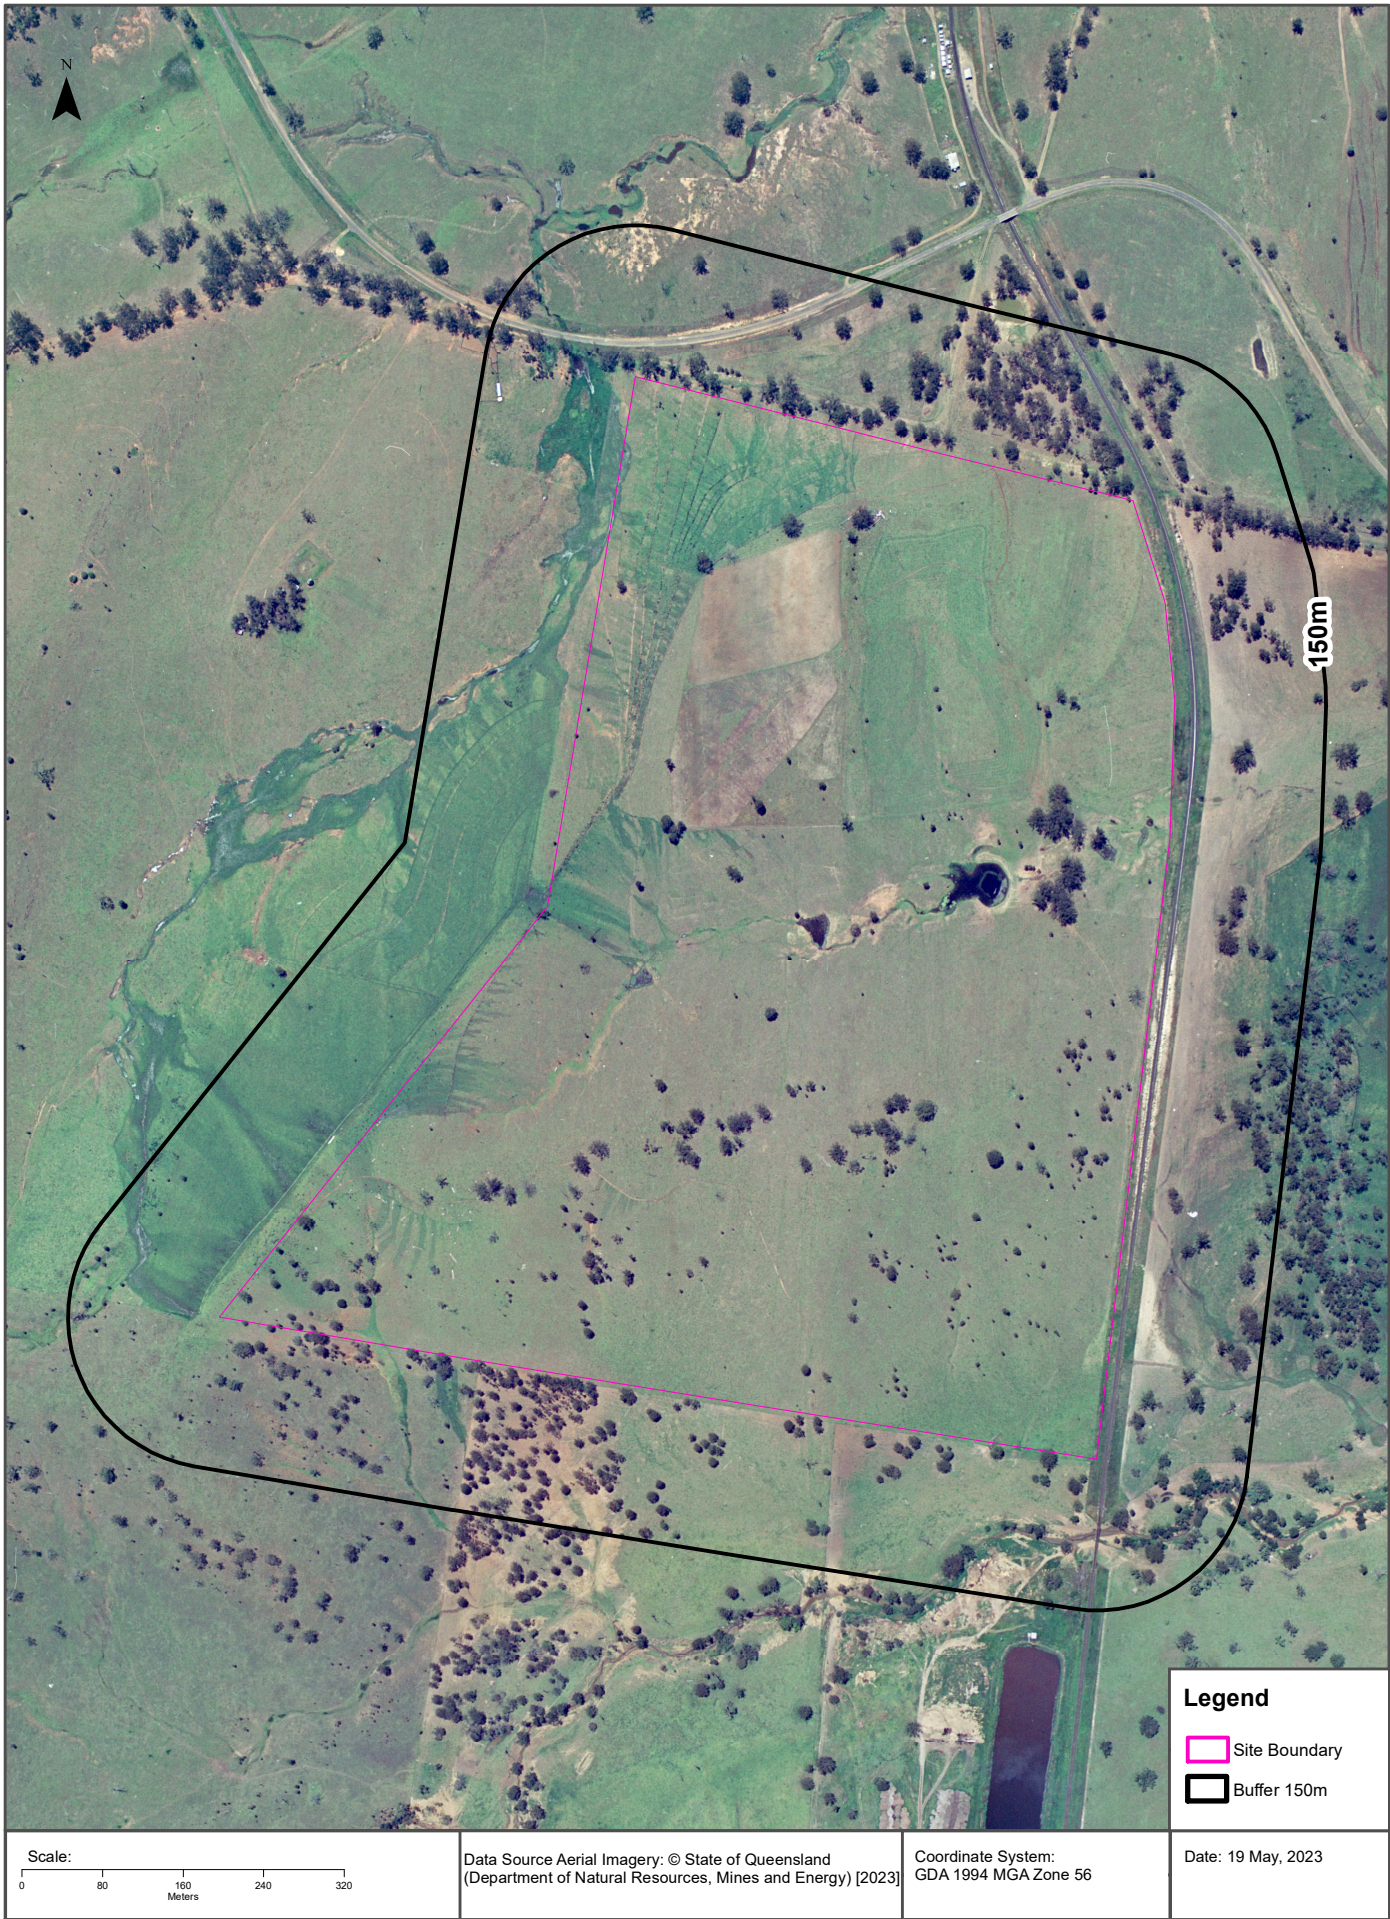
# Aerial Imagery 1974

| Year | Lot 1 on RP45234 | Surrounding land use |
|---|---|---|
| 1974 | Fencing and small agricultural structures (possibly a cattle yard) appeared to have been constructed in the north-western section of the lot (and within the site boundary). | Several structures appeared to have been constructed approximately 200 m north of the site and 150 m west of the site. Additional smaller structures and potential tanks were observed around the original small building to the west of the site. A large retention basin/dam and earthworks were observed south-east of the lot. The possible cattle yard/cattle dip previously observed located approximately 450 m north-west of the site appeared to have been removed. |
